# USE OF INNOVATIVE *PMCap*<sup>(Patent 6,860,297)</sup> REPAIR FOR LP FEEDWATER HEATER SHELLS AT WOLF CREEK

## **ABSTRACT**

## “Use of Innovative PMCap<sup>Patented</sup> Repair for LP Feedwater Heater Shells at Wolf Creek”

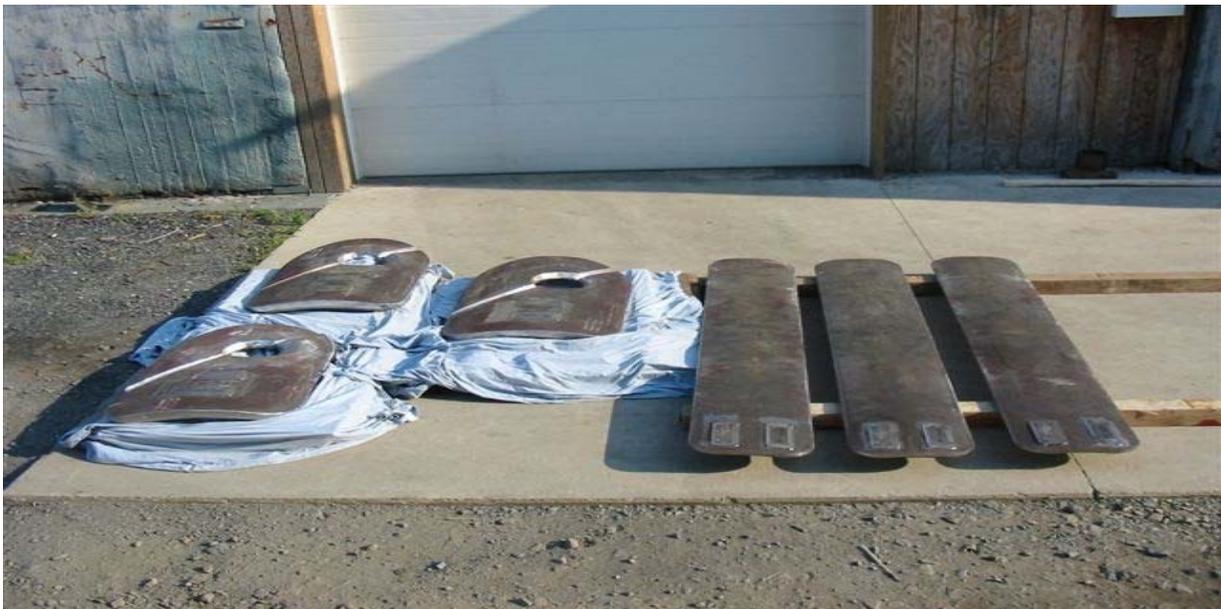
**PMCaps – Ready for Shipment**

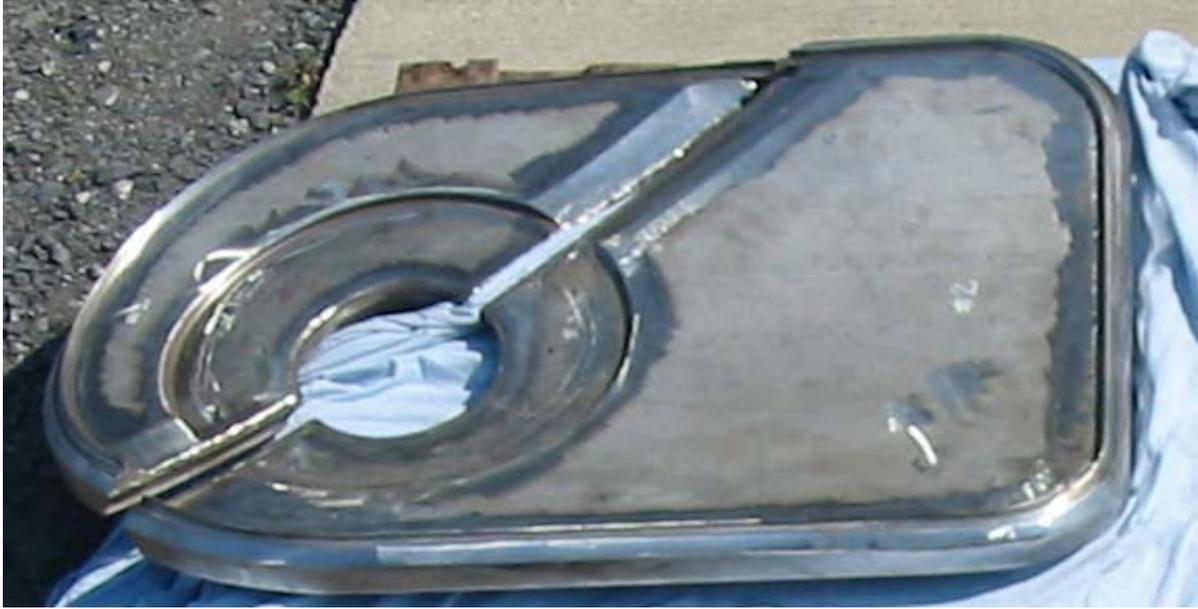
**As-Constructed Split *PMCap* (Underside View)**

The nozzle cap was supplied in two pieces so that it could be installed around the drain inlet nozzle without having to cut the piping. All caps were brought to the job site without having to remove any obstructions. It is noted that the suggested flush patch was required to be so large that it would not have been possible to negotiate the congested turbine building area without additional work, including removal of adjacent piping. Lifting lugs were welded on to the caps by Wolf Creek to allow for easier handling and final positioning on the shell. Jack screws were attached to the shell to secure the caps in position during the welding. Wolf Creek elected to utilize an elevated preheat on all welds to assure final weld integrity. On all full penetration welds, the root pass and final weld pass were MT examined. Prior to installation of the caps, UT thickness measurements were taken of the degraded shell sections and flaw detection UT was utilized to verify shell integrity at the location of the attachment weld. Post installation, UT baseline thickness measurements were taken around the periphery of the caps at the Category D welds.

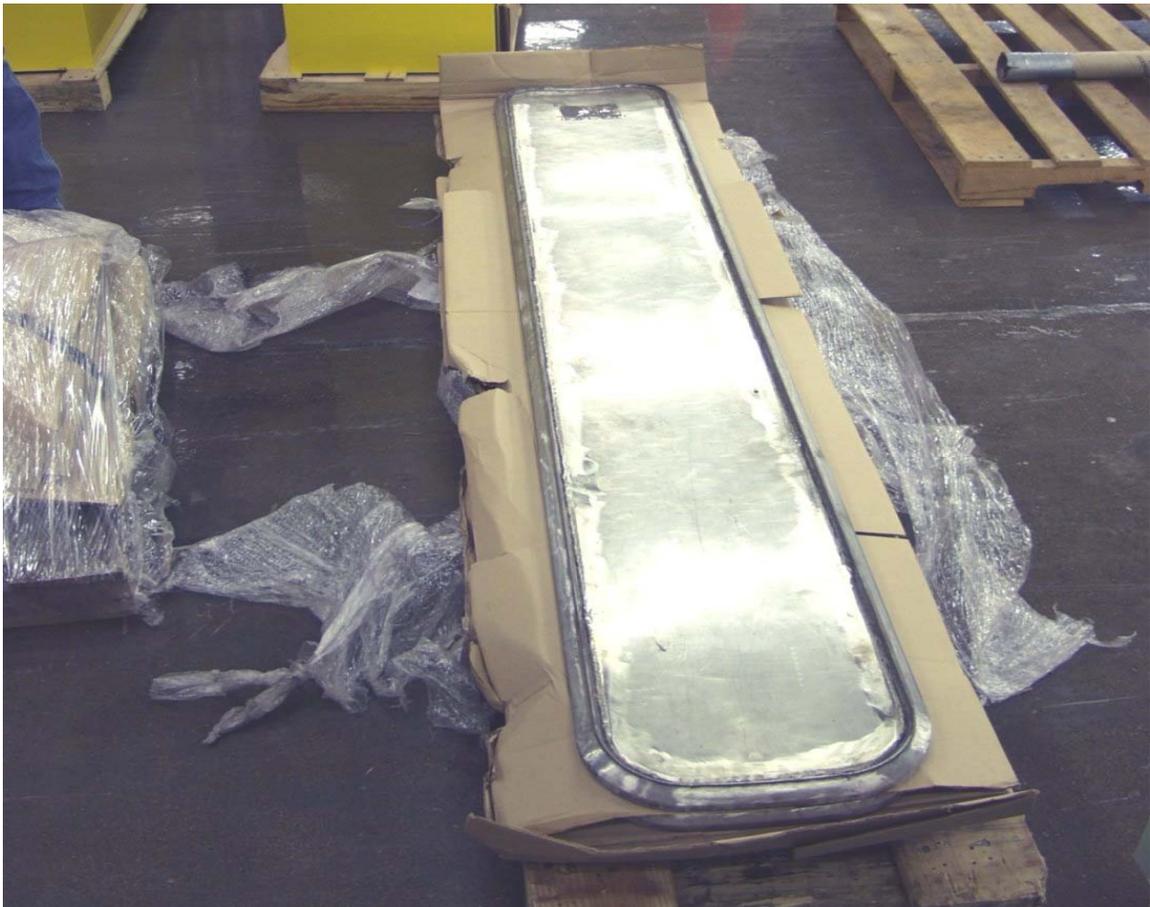
## 7' x 14" Rectangular PMCap

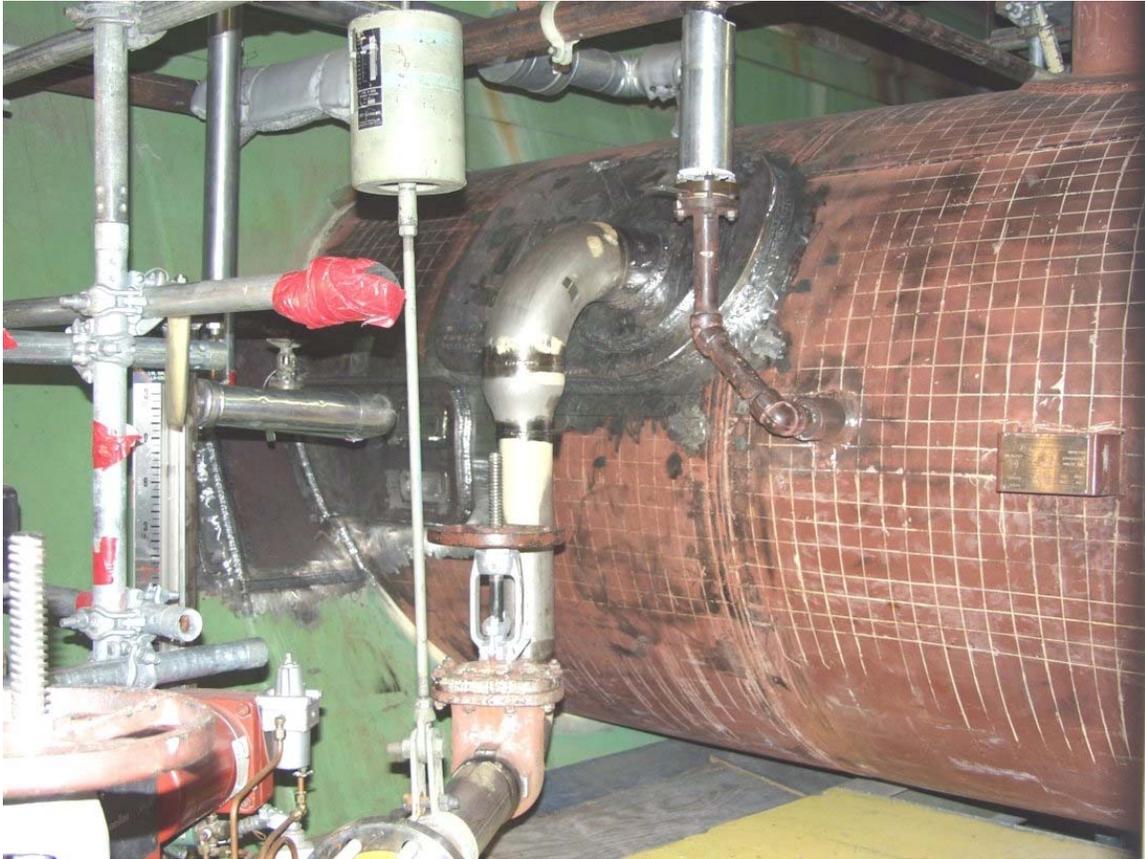
**Completed *PMCap* Installation**
